**Independent investigation of the
major incident occurred on the
15th of June 2022 at skyguide**

1. Introduction

1.1. Purpose

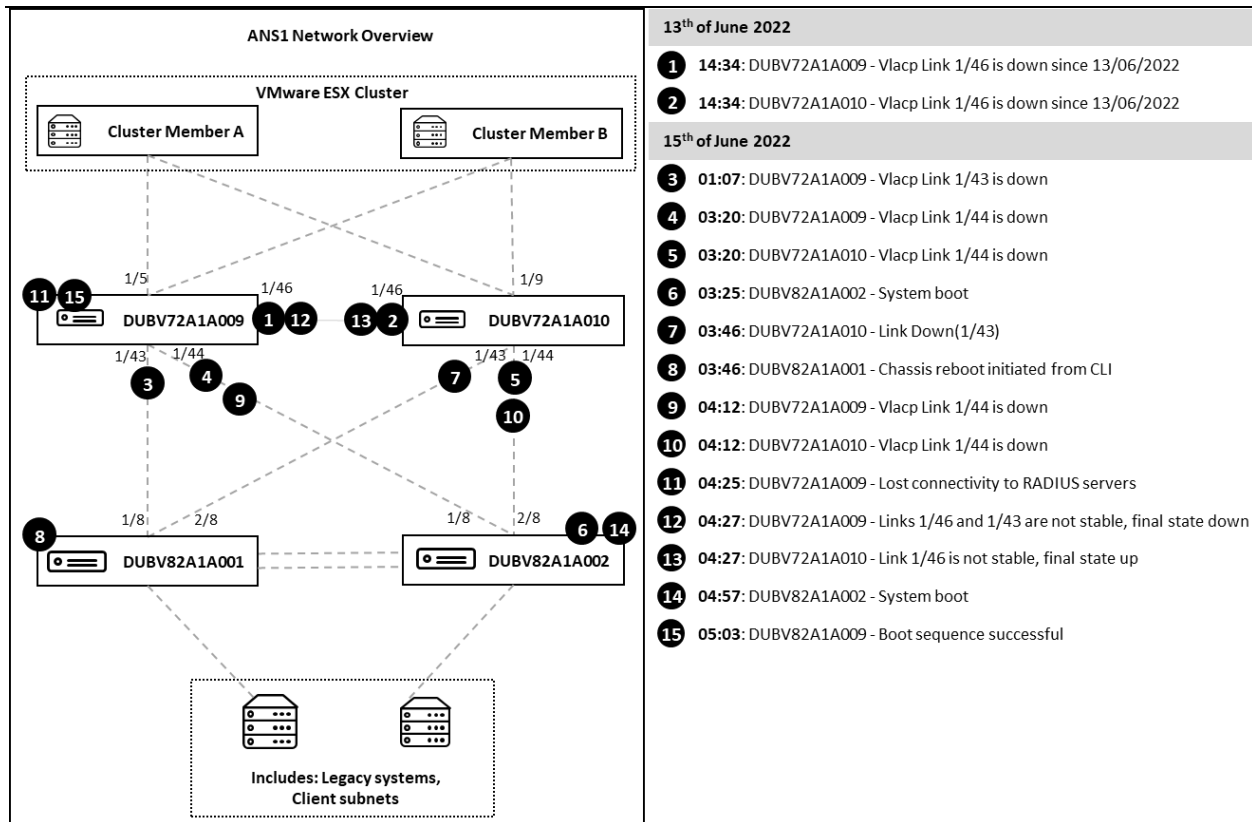
Figure 6: Events which occurred on the 13th and 15th of June 2022

What was found as a precursor of the events which took place on the 15th of June 2022, was an event which occurred 2 days earlier, on 13th of June 2022. All below references are referring to above Figure 6.

The network was able to operate without impact on operations through the remaining part of 13th of June 2022 and whole day on 14th of June 2022. This was possible because the communication concluded through switch 01 and switch 02, which acted as an intermediary. However, on 15th of June 2022 new failures occurred.

As the network issue was not resolved, switch 02 was accessed at 04:02 and later shut down at 04:12 (9) (10). Switch 01 was accessed at 04:19, 04:23 and at 04:25. At 04:25, switch 09 lost connectivity to RADIUS servers (11), which indicates connectivity issues. At 04:27 network team started working on switch 09 and switch 10 in order to restore connectivity on ports 1/43 and 1/46 (12) (13). Switch 02 was rebooted at 04:57 (14). After logging in directly to Switch 09 and analyzing the data, the team understood what information was missing in the monitoring, verified it on other devices and decided to restart Switch 09. Log information from switch 09 had to be obtained by physically connecting to the switch, as the network connectivity to the switch was not allowing to effectively download the information. Switch 09 completed the booting process at 05:03 and afterwards stability of the network was evaluated. Level 3 - Network Engineering confirmed the status of the network as stable at 05:30.

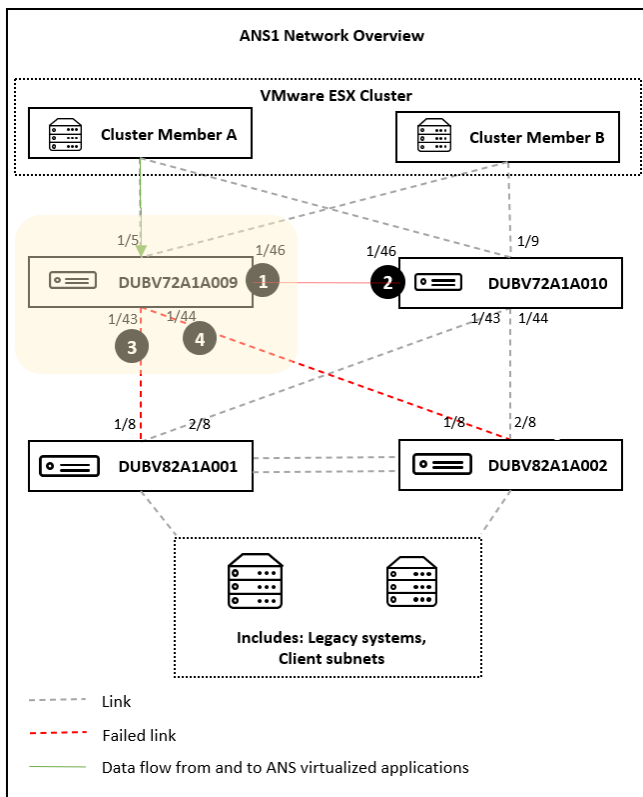
As outlined and summarized in Extreme Network's Case#:02612557 "Skyguide Root Cause Analysis", switch 09 experienced Vlacp link being down, which was resolved after the network switch reboot. The first link which became down was on port 1/46, which is connected switch 10. This is shown as (1) and (2) in Figure 7. Network traffic was automatically routed around the failed link. This occurred on 13th of June 2022 at 14:34. The historical data available in PRTG monitoring tool confirms that that the network traffic was stopped on this port. The network switch vendor analysis confirms that the physical

layer was still operational, however the network packets were being dropped. This can be seen in the network switch port statistics. The lack of data transmission caused switch 09 and switch 10 to disable the Vlacp link between them.

On 15th of June 2022 at 01:07 Vlacp link on port 1/43 linking to switch 01 became down (3) and is visible in the number of dropped packets on QoS queues zero, one, six and seven. This caused the network switch 09 to have only one remaining link route to the remaining part of the network. Switch 09 automatically rerouted the network traffic through the last available port 1/44 which is linking to switch 02, however this port was operating only partially (4). The partial operation of the port is visible in port statistics, where QoS queues zero and one have shown network packets loss. The packet loss was at a level which still allowed some network communication to still be sent correctly, as confirmed during the interviews and visible in

- ① 14:34: DUBV72A1A009 - Vlacp Link 1/46 is down (not visible in monitoring tools)
- ② 14:34: DUBV72A1A010 - Vlacp Link 1/46 is down

PRTG port monitoring logs. As outlined by the vendor's root cause analysis, the control plane on port 1/44 continued to operate. The control plane has maintained port 1/44 status as operational, however not all data was being transferred due to the errors. Errors which caused packet loss occurred only on lower level QoS queues and the control plane traffic was not impacted.

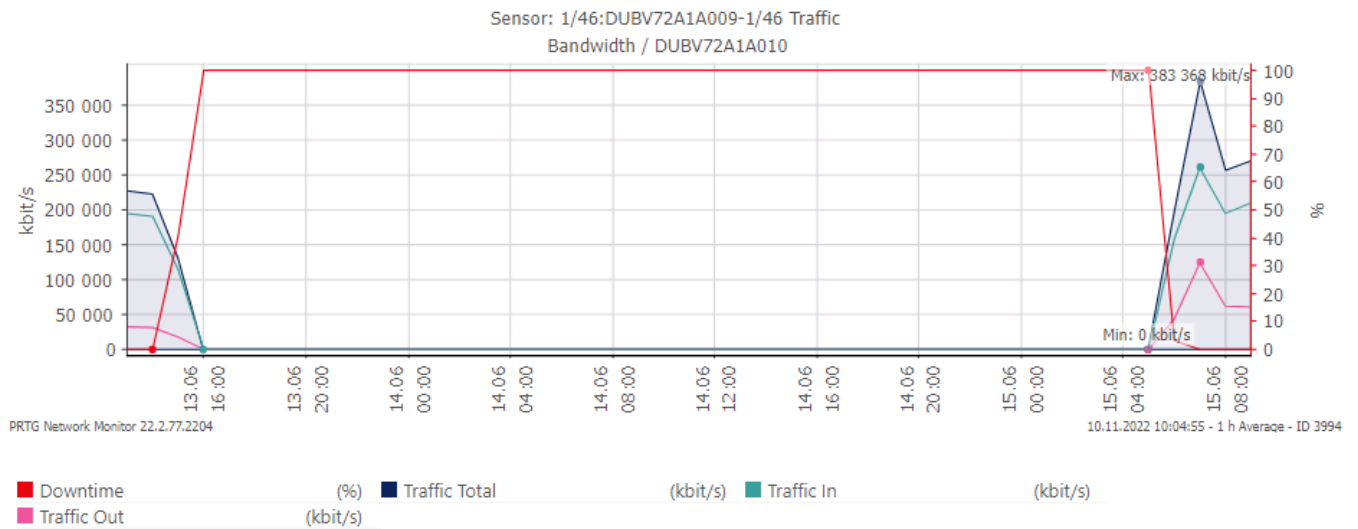
Our analysis has shown that first issue on the network switch which caused an outage on 15th of June 2022, occurred on the 13th of June 2022. Two network devices (switch09 and switch10) reported that Vlacp link was down on port 1/46. This error was detected by Level 1 - SMC monitoring on switch 10 and XIQ monitoring. Level 2 - Network Operations checked the status of the port on switch 10. Switch 10 reported to XIQ monitoring tool that link is down and that the port is still operational. Switch 09 was reported in XIQ to be operating correctly. The changes in network traffic were not investigated in depth using skyguide's second monitoring tool, PRTG (see Figure 12 and Figure 13).

Figure 12: PRTG log for network switch 10 port 1/46 between 13th and 15th of June 2022

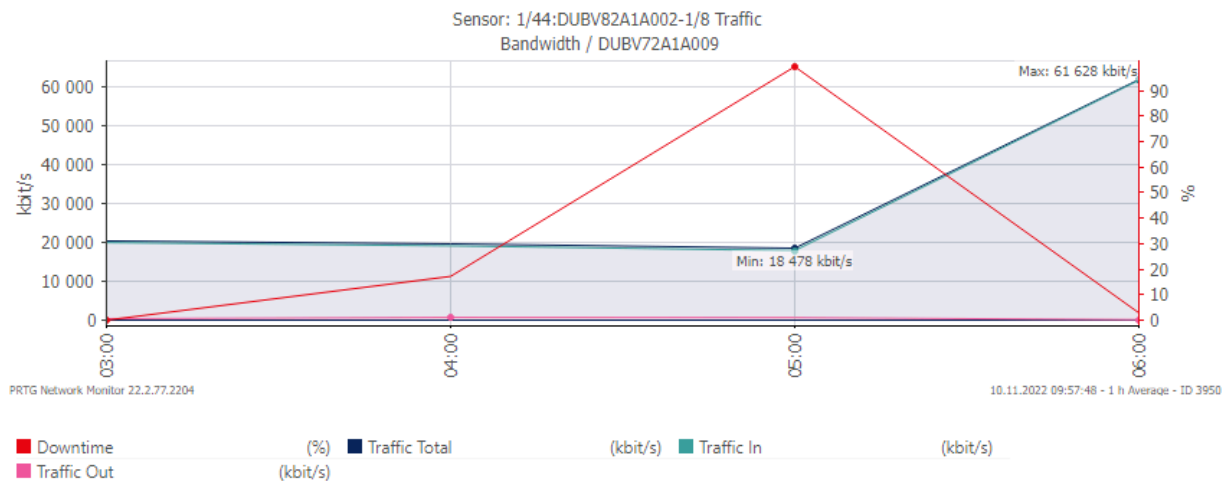
The XIQ tool reported at 01:07 a significant number of alerts, which needed to be investigated by Level 2 - Network Operations. At this point in time, the link on port 1/44 originating from switch 09 destined to port 1/8 on switch 02 was still reported as operational. The root cause analysis of the switch vendor outlines that a partial impact on port 1/44 on switch 09 was not detected by the switch 09. Furthermore, drop packets on switch 09 port 1/44 were reported for QoS queue 0 and queue 1 (used for application traffic), but not on queue 7 (used for the control plane traffic like Vlapc, vIST and IS-IS). Switch 09 port 1/44 was determined as operational by the switches control plane and by neighboring network devices. The switch vendor confirmed that, at that point in time, data being transferred between switch 02 and 09 was dropped by switch 09. This was further confirmed in the network switch logs analysis and in the historical data of PRTG monitoring tool (see Figure 12, Figure 13, Figure 14).

Figure 14: PRTG log for network switch 09 port 1/44 between 3:00am and 06:00am on 15th of June 2022
