**Independent investigation of the
major incident occurred on the
15th of June 2022 at skyguide**

1. Introduction

1.1. Purpose

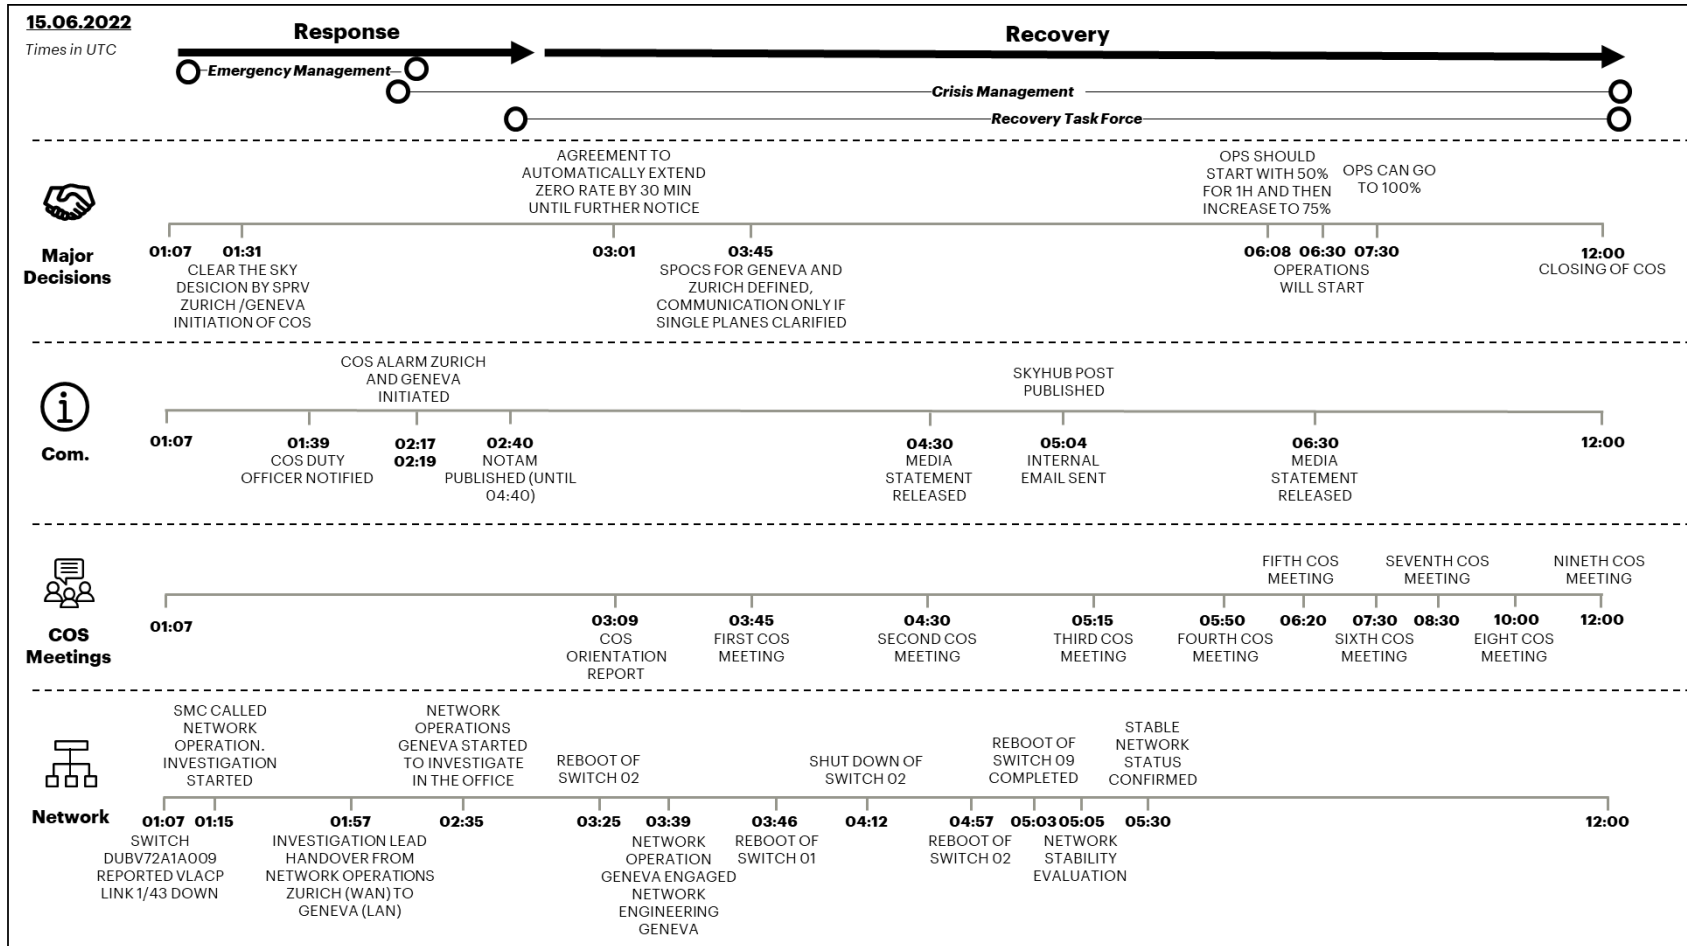
Figure 3: Overview of Timeline

Figure 3 provides an overview of the major events of each category described above. The overview is structured according to skyguide's BCM (Business Continuity Management) Framework and its phases (Response, Recovery, Emergency- and Crisis Management, Recovery Task Force). Please note that this overview contains the main events but does not contain every single phone call and events related to network which already occurred on the 13th of June 2022. A more detailed timeline can be found in chapter 11.

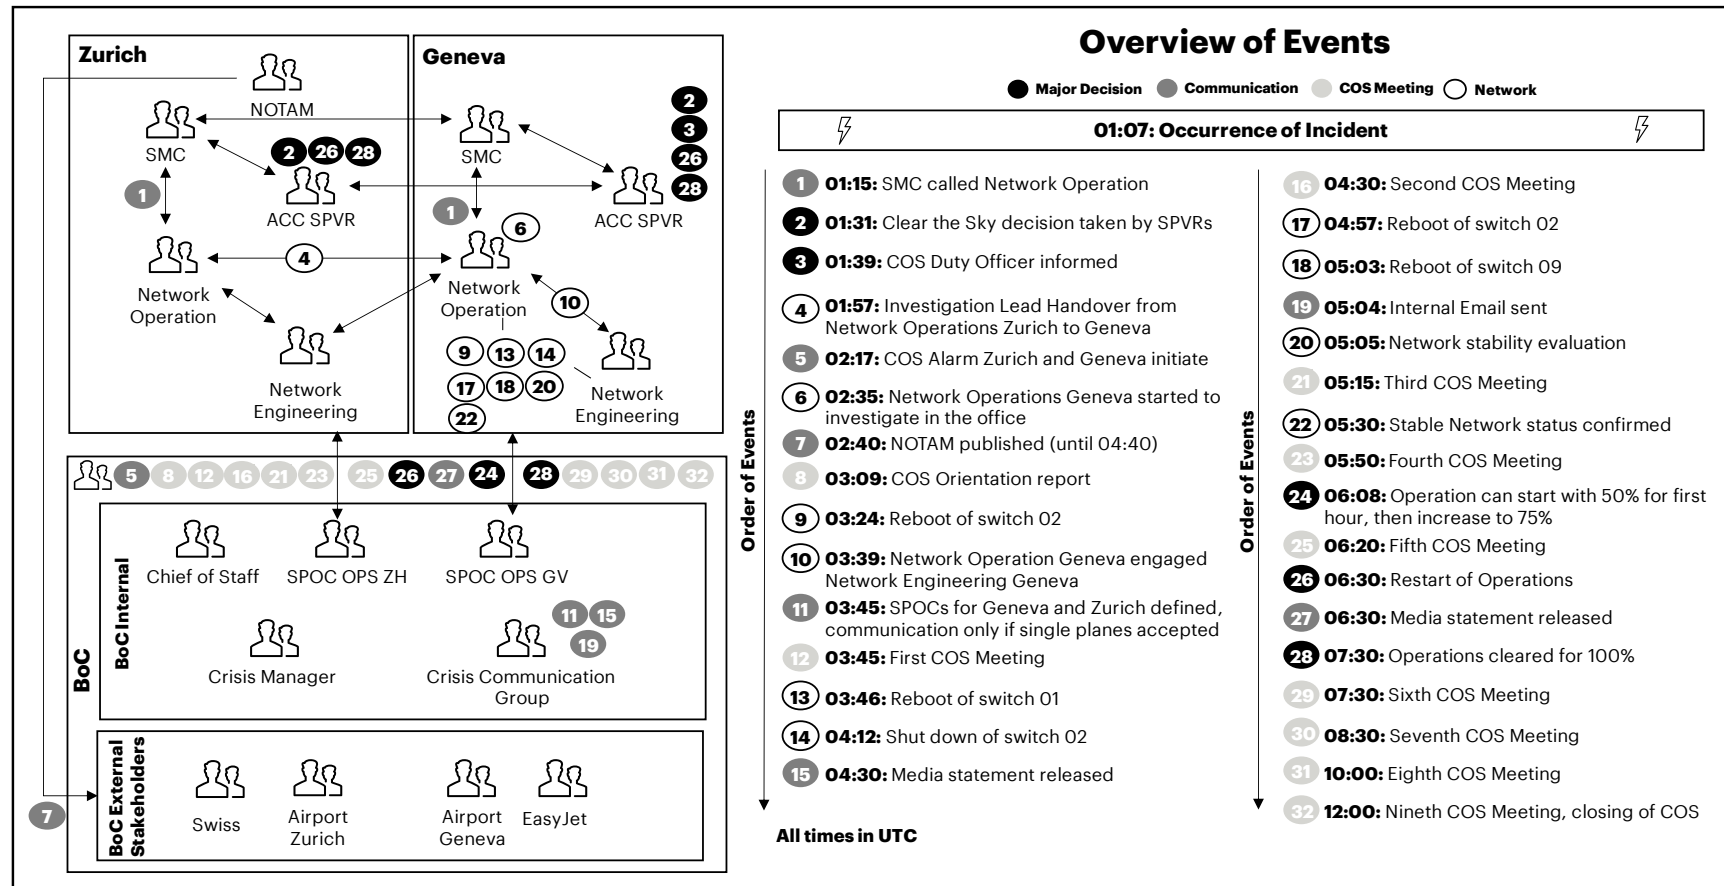
Figure 8: Overview and Sequence of Events (UTC)

The following figure shows an overview of all events and related actors.
